R-90-08

HYDRAULIC MODEL STUDY OF THE THEODORE ROOSEVELT DAM SPILLWAY MODIFICATIONS

July 1990

U.S. DEPARTMENT OF THE INTERIOR
Bureau of Reclamation
Denver Office
Research and Laboratory Services Division
Hydraulics Branch

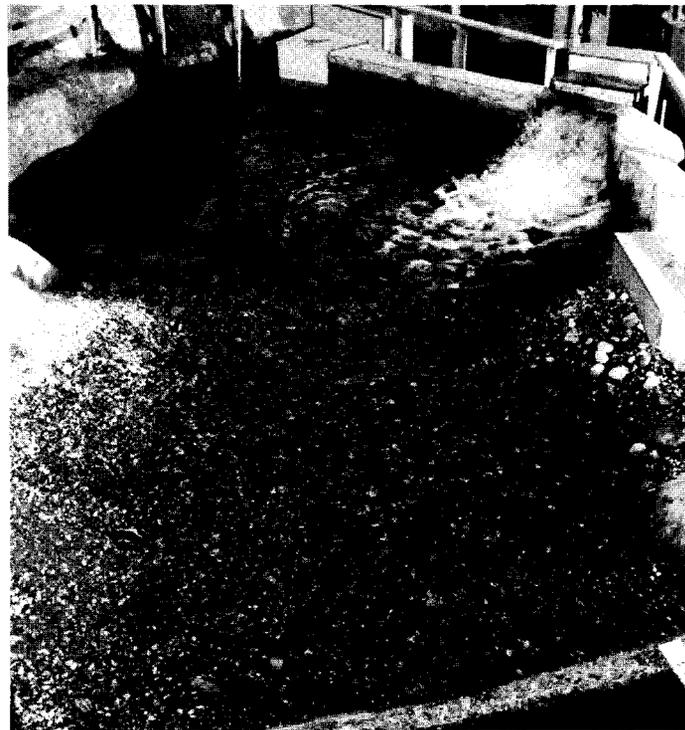
Figure 41. - Outlet works operation at $Q = 11,517 \text{ ft}^3/\text{s}$ and reservoir elevation 2175.

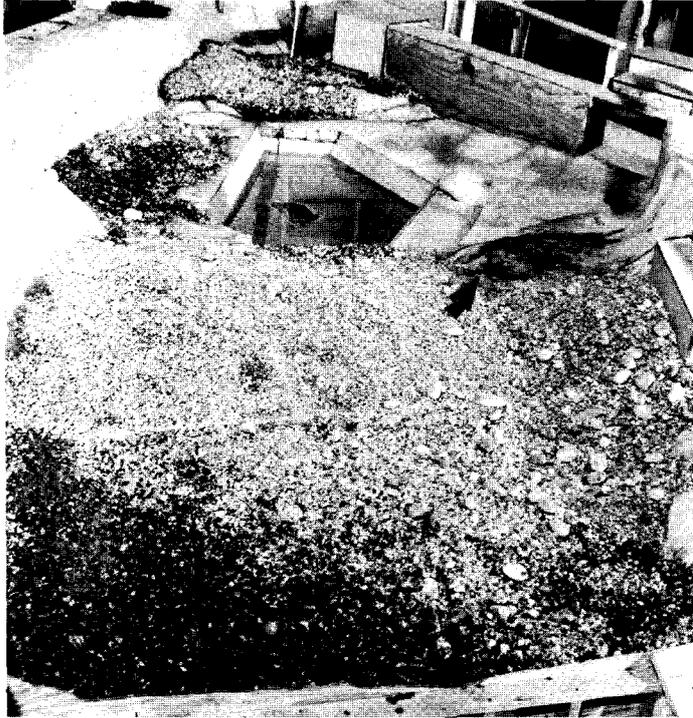
Figure 42. - Alluvium patterns after cumulative outlet works and right spillway discharges up to 25,000 ft³/s at elevation 2175.

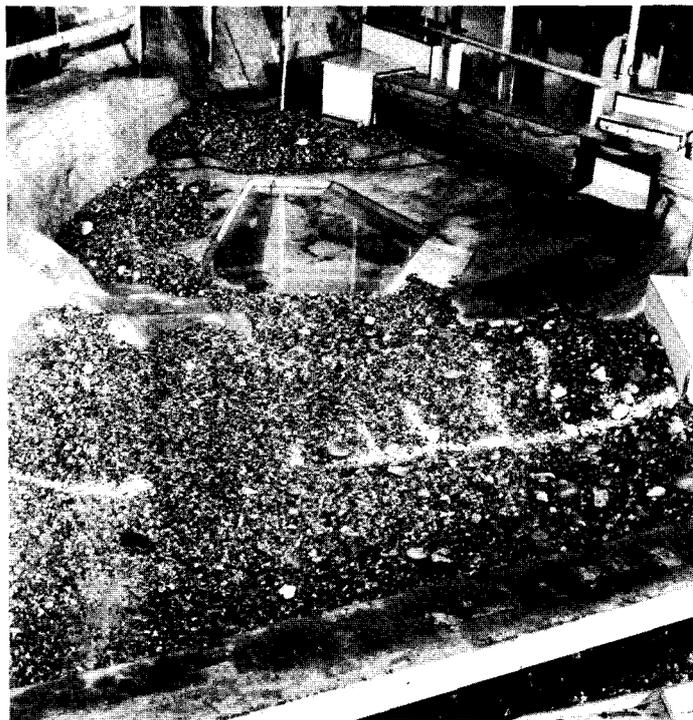
Figure 43. - Alluvium patterns after a total of 70,000 ft³/s at elevation 2175 through both spillways.

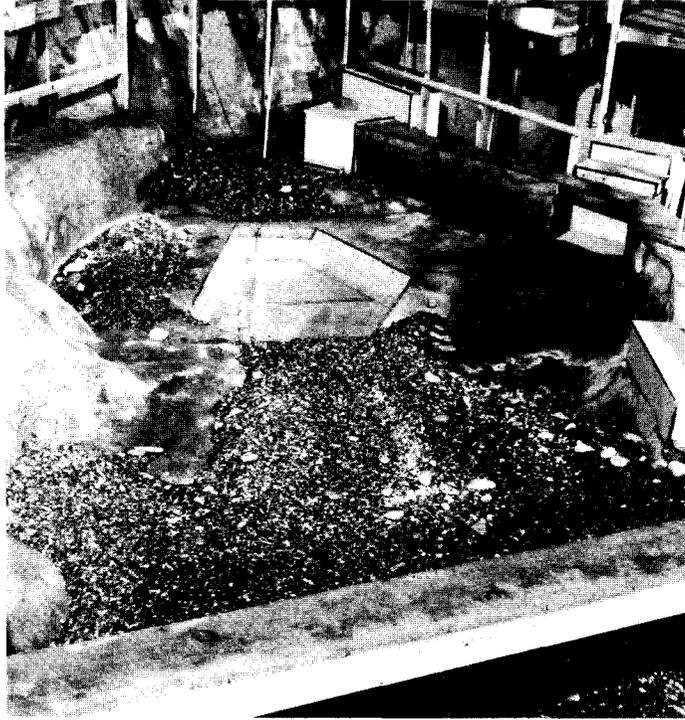
Figure 44. - Alluvium patterns after operation of the design discharge.

The design discharge, 135,000 ft³/s at elevation 2175, and PMF, 150,000 ft³/s at elevation 2218, were tested for 14 and 4 hours, respectively. These durations were determined from the flood routings. During both of these tests, material from the right side of the pool continued to enter the pool but was then swept out and deposited downstream. Material below the downstream edge of the pool was no longer drawn into the pool but was eroded and deposited further downstream. Material was eroded from the right side of the channel downstream of the hole, along both sides of the downstream river channel, and from in front of the warehouse to the elevation of the rock contours (figs. 44 and 45). Again, no material moved at the toe of the dam.

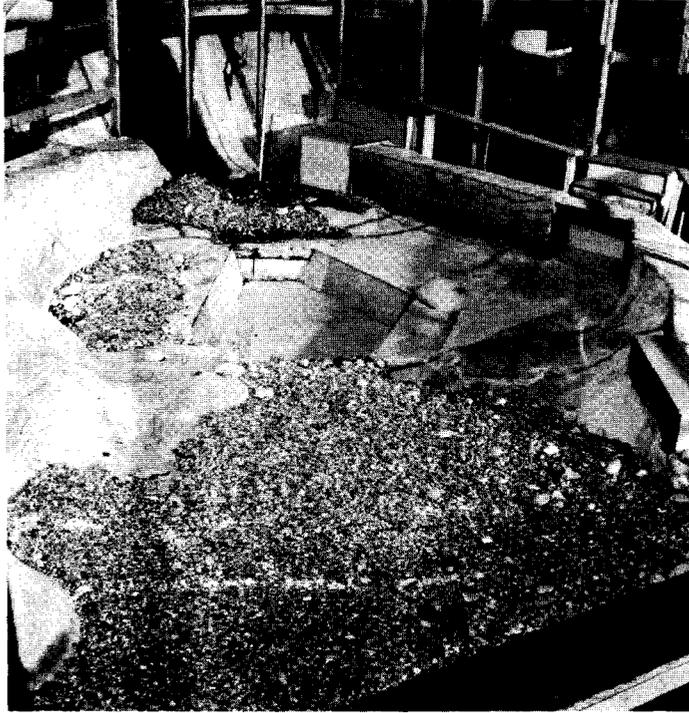
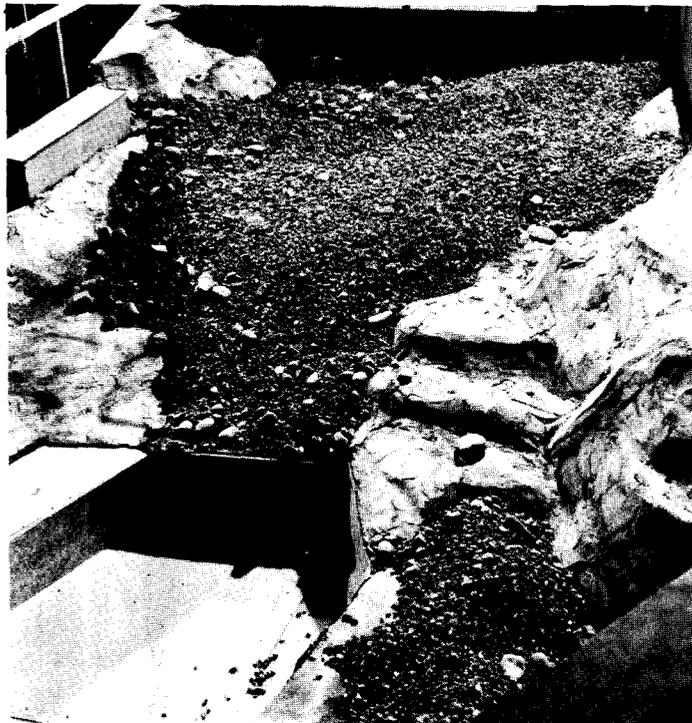
Figure 45. - Alluvium patterns after operation of the PMF.

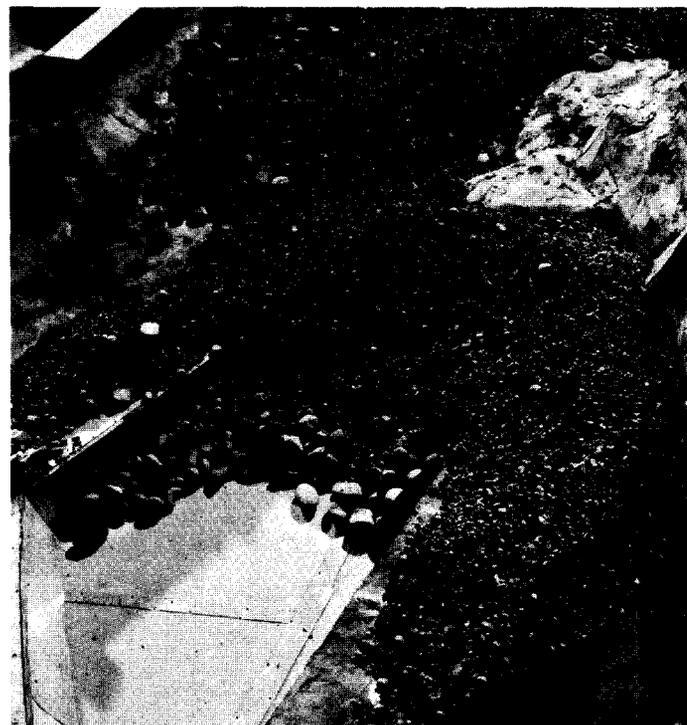
Figure 46. - Plunge pool after operating under design discharge with material in the pool at the beginning of the test.

An attempt was then made to simulate movement of material eroded from an unlined pool under the design condition. With the erosion pattern remaining from the previous test, the entire floor of the plunge pool was covered with about 20 feet of the same alluvial material. The material was washed from the upstream portion of the pool, depositing in the downstream end of the pool and river channel (fig. 46).

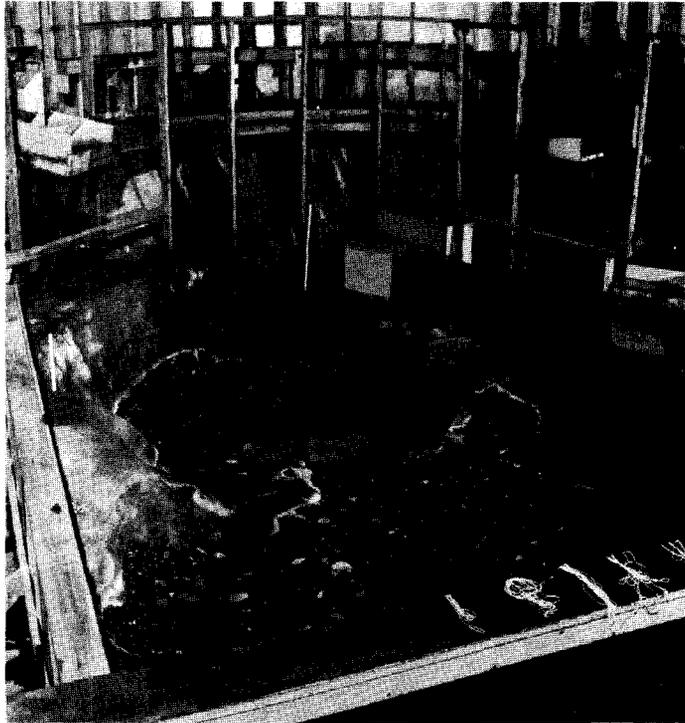
Figure 47. - Erodible concrete forming the upstream side walls of the recommended pool for the DCAD option.

The upstream side walls of the plunge pool were replaced with an erodible concrete mixture to investigate the possibility of high-velocity jets causing erosion upstream toward the dam toe or the powerplant road. Several trial mortar mix samples were prepared and tested for erosion. A mix of 30 parts sand, 1 part cement, and 2 parts water by volume was used. The mortar was placed and allowed to set overnight (fig. 47). Prior to testing, the walls could be eroded by scraping the surface with one's hand. The design discharge was tested first without and then with material in the plunge pool at initial startup. No erosion of the side walls occurred with the pool initially free of material. When tested with material in the pool, most of the material again washed out or armored the downstream slope. However, a couple of large rocks remained in the upstream portion of the pool, ball milling both side walls. No ball milling was observed on the most upstream face of the pool (fig. 48).

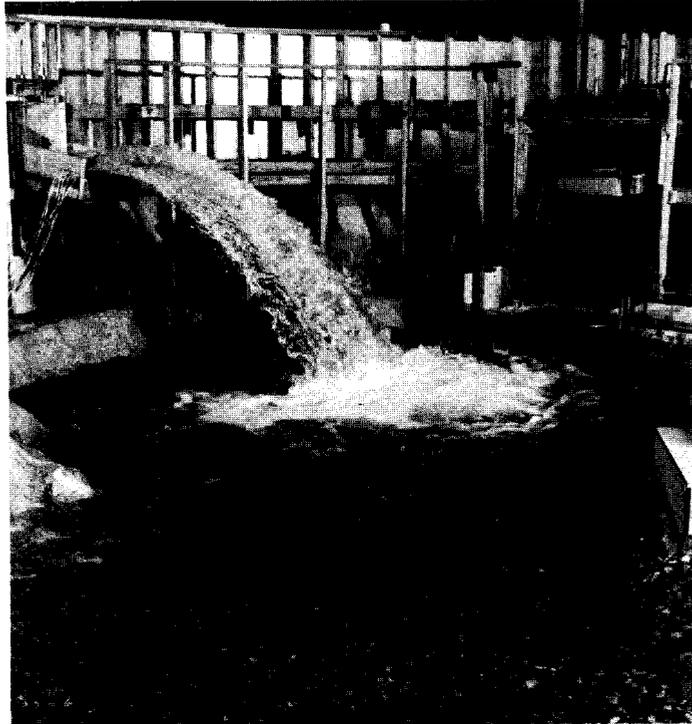
Figure 49. - Right spillway operation at 25,000 ft³/s and elevation 2175 for the final plunge pool design of the SCAD.

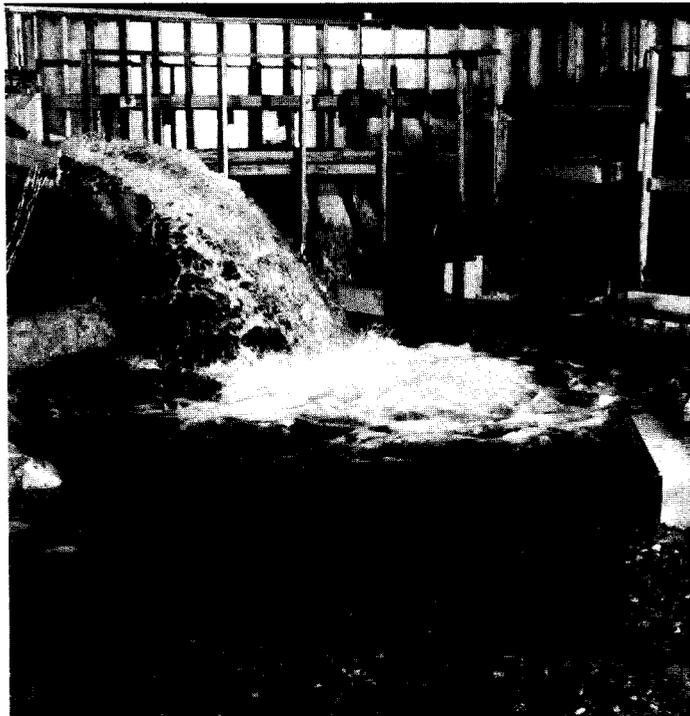
Figure 50. - Right spillway operation at 41,000 ft³/s and elevation 2175 for the final pool design of the SCAD.

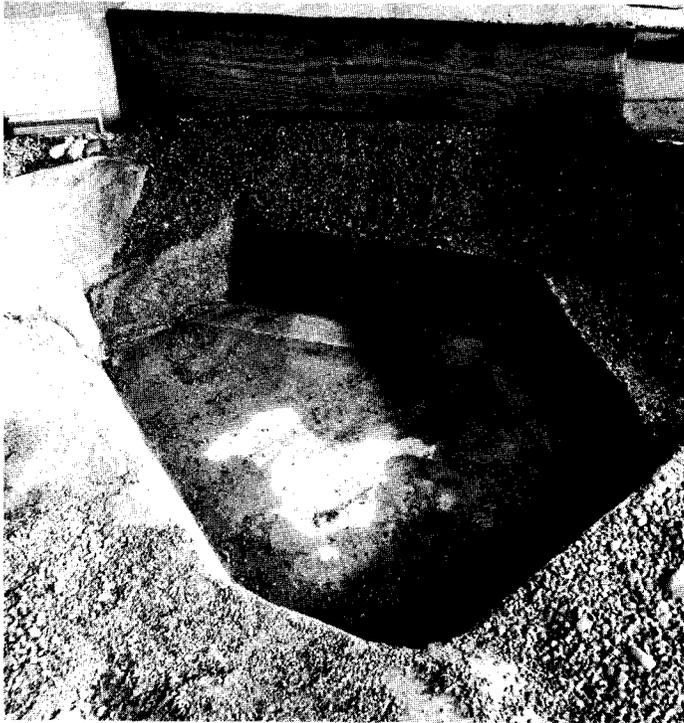
Figure 52. - Erodible bed material forming plunge pool walls and area adjacent to powerplant road for the final SCAD design. (Outlet works structure is shown in upper right corner of photograph.)

Additional tests were then performed to investigate the effect of outlet works and right spillway flows on the powerplant road retaining wall. There was concern that the close proximity of the plunge pool would cause undermining of the road if the plunge pool eroded further. The fixed upstream and left edges of the plunge pool and the topography between the plunge pool and the powerplant road were replaced with erodible material. The material consisted of a pea gravel and sand mixture. The pool walls and surrounding topography were built up in layers. Each layer of material was compacted and then covered with a thin layer (1/16 inch) of cement. The cement was used to produce thin horizontal lenses within the erodible material. The cement lenses prevented the material from slumping at the angle of repose of the material. A thin layer of cement (1/16 inch) was also placed over the face of the finished pool walls and topography (fig. 52). The material was fixed only enough to hold the shape of the plunge pool walls; there was basically no cohesiveness.

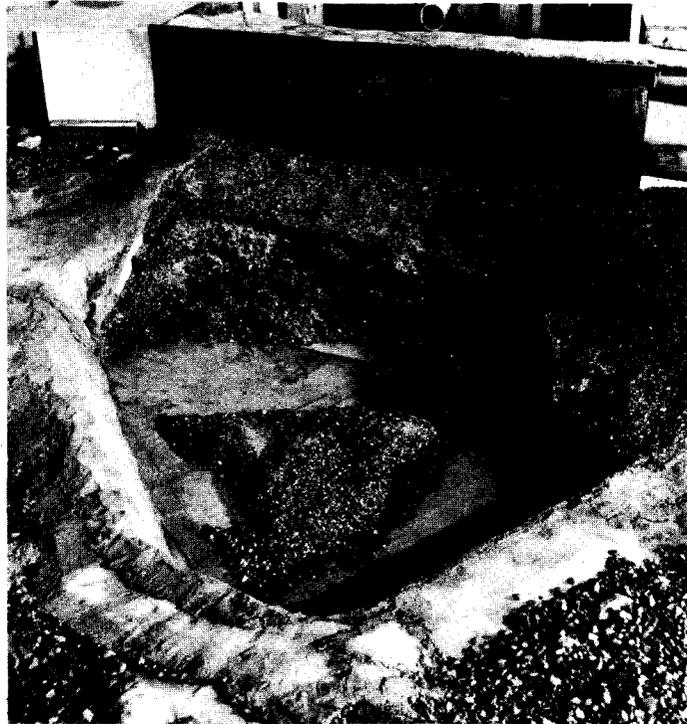
Figure 53. - Erosion pattern after operating at elevation 2151 with about 11,000 ft³/s through the outlet works and 14,000 ft³/s through the right spillway of the SCAD. (Outlet works structure is shown in upper right corner of photograph.)

Progressive erosion tests were then documented for a total discharge of 25,000 ft³/s. During initial filling to the tailwater elevation, the saturated material settled somewhat and the upstream pool wall slumped. As the upstream wall has shown no potential for erosion in previous tests, the slumped material was left and the tests were continued. For the first test, 11,000 ft³/s was released through the outlet works and 14,000 ft³/s from the right spillway at elevation 2151. This flow condition is the most likely operation. Some erosion occurred along the side wall near the upstream edge of the right spillway jet with no erosion from the outlet works operation (fig. 53). Material eroded from the side wall was deposited in the pool just downstream and to the right of the edge of the jet. No erosion occurred near the powerplant road retaining wall.

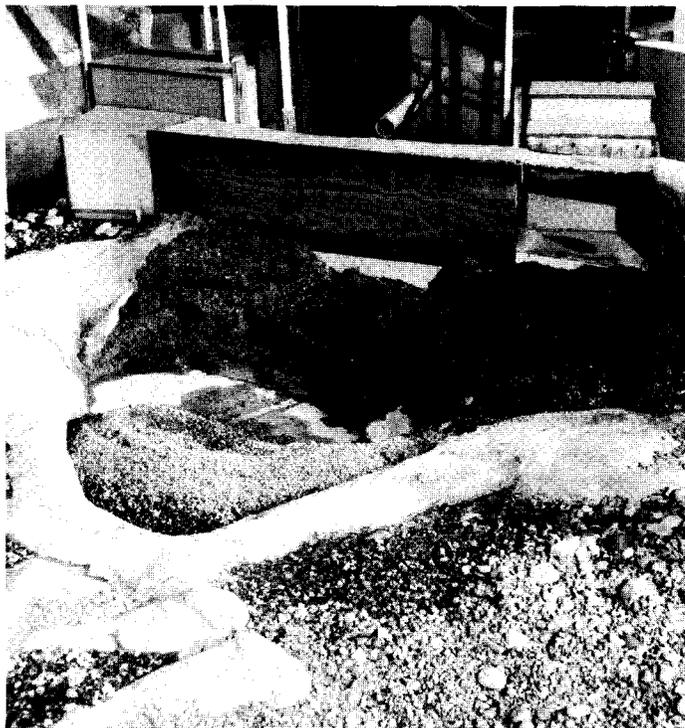
Figure 55. - Erosion pattern after operating at elevation 2175 with 25,000 ft³/s through the right spillway of the SCAD.

The right spillway was then operated to 25,000 ft³/s at elevation 2175. This basically followed the same erosion pattern as the previous test with more material removed from the previously eroded areas. The extent of the erosion near the base of the powerplant road did not grow parallel to the road, but did deepen slightly (fig. 55). Material continued to be deposited in the plunge pool toward the downstream end and underneath the jet.
